2018 Ranger 27' Tug, Luxury Edition

Report of Marine Survey

Conducted by
Raymond M. Toth, CD NAMS-CMS

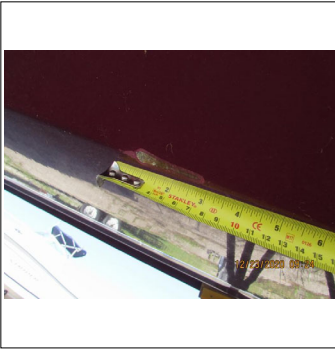
Below the waterline moisture levels were between 0-15% excepting the areas in the vicinity of the laminate failure. A second gouge was noted in the centerline at the transom. See findings for details.

Impact on Transom Centerline

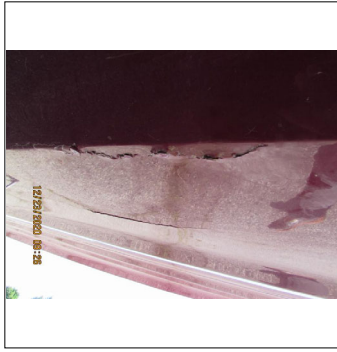
Gelcoat over FRP. Minor scrapes noted with two large longitudinal fractures noted in the gelcoat and FRP laminates 1" to the port side of the centerline and 134" aft of the stem. See findings for details.

FINDINGS	RECOMMENDATIONS
The area below the waterline 40" forward of the two longitudinal hull fractures and 60" aft reacted poorly when percussion sounded and moisture levels were recorded at 60-100% with delamination noted in these areas. Inspection of the bilges near the damaged area (where accessible) revealed loose bonding puddy used to secure some of the secondary framing as well as the depth sounder transducer being adrift. Cracking was also noted in the aft bilge pump fairing mount which is directly above the second gouge on the centerline at the transom.	Further destructive testing is required to fully gauge the extent of the damage. The vessel is not considered fit for its' intended use and a major repair is expected. Given the wide area of moisture levels in the laminates and the degraded substrate, this damage is not recent with the physical evidence provided.

Longitudinal Fractures Port side Centerline

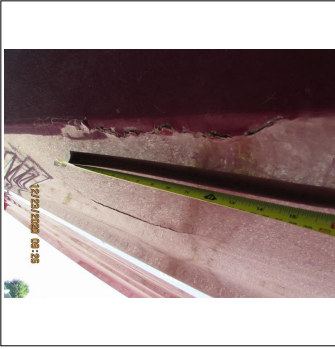
Length of Fractures

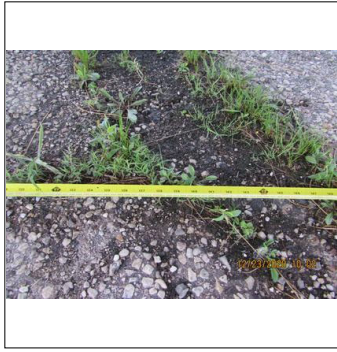
Location of Port side Fractures from Stem

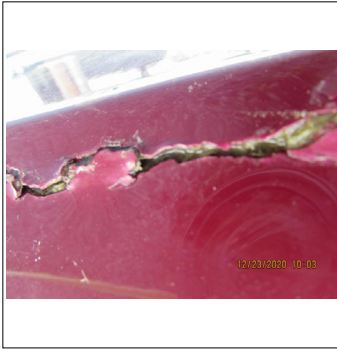
Close up of Inboard Fracture Partial

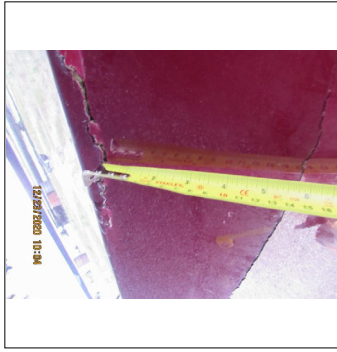
Distance between Longitudinal Fractures

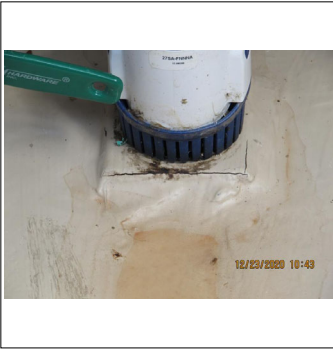
Cracked Fairing Puddy for Bilge Pump Mount directly above Stern CL Impact

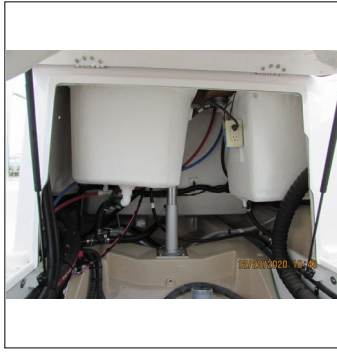
FINDINGS	RECOMMENDATIONS
A 125VAC NEMA 15 GFCI receptacle was installed in the gasoline generator and fuel tank space.	The receptacle is not IGNITION PROTECTED and must be removed from the gasoline space to prevent fire or explosion in accordance with CFR and TP1332.

125VAC Receptacle Installed in Gasoline Fuel Space

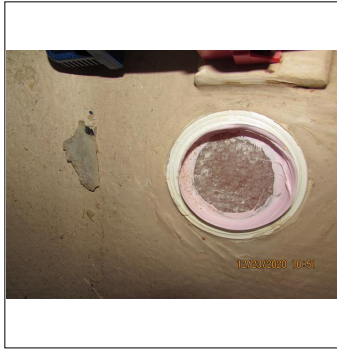
FINDINGS	RECOMMENDATIONS
Several loose pieces of bonding puddy were found in the forward bilge and inspection of the framing was not possible due to the construction of the vessel.	Further non-destructive testing is required to determine the structural integrity of the vessel.

FINDINGS	RECOMMENDATIONS
The depth sounder transducer is adrift in the forward bilge.	Reinstall prior to launch.

Transducer Adrift From Adhesive & Bonding Puddy Adrift

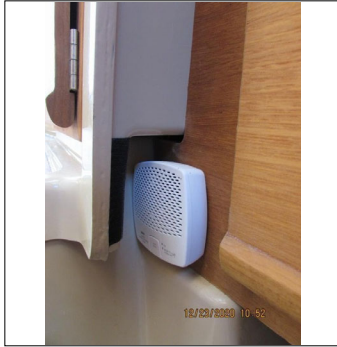
FINDINGS	RECOMMENDATIONS
The CO detector in the forward cabin is improperly mounted.	A carbon monoxide detector shall be installed on all boats with an enclosed accommodation compartment and meet the requirements of UL 2034, have a lower limit of 30 PPM CO and Beta of 10% minimum with a sound pressure of at least 85 db at 10 ft and installed in accordance with ABYC E-11 and ABYC-24.

CO Detector Improperly Installed
