2018 Ranger 27' Tug, Luxury Edition

Report of Marine Survey

Conducted by
Raymond M. Toth, CD NAMS-CMS

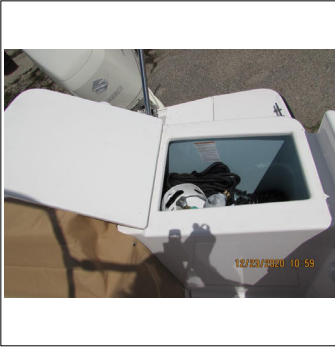
NO Gasket Installed on Lid of LPG Locker
