2018 Ranger 27' Tug, Luxury Edition

Report of Marine Survey

Conducted by
Raymond M. Toth, CD NAMS-CMS

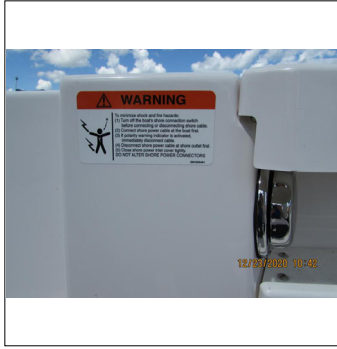
IMG_5962

English Only Warning Labels

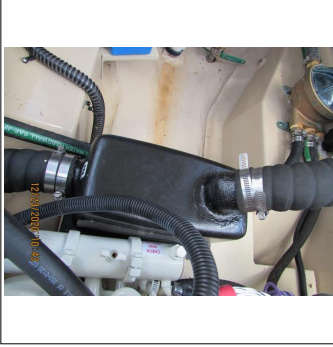
Hose Clamps Overlapping Each Other

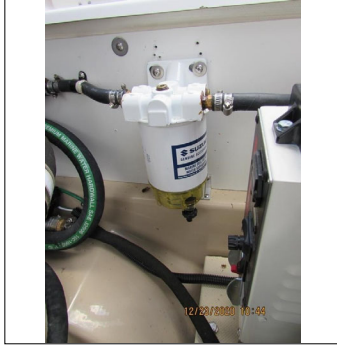
Fuel Filter with Poly sight bowl in Generator space

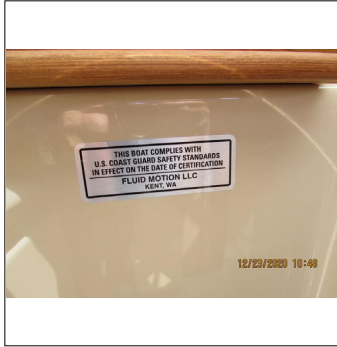
No Complimentary Transport Canada Tag On Board

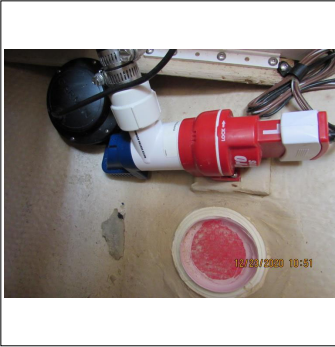
Transducer Adrift From Adhesive & Bonding Puddy Adrift
